**FT-102 Modification**  
**Modification to improve the transceiver performance**

This modification will provide better switching on the transmit and receive functions.

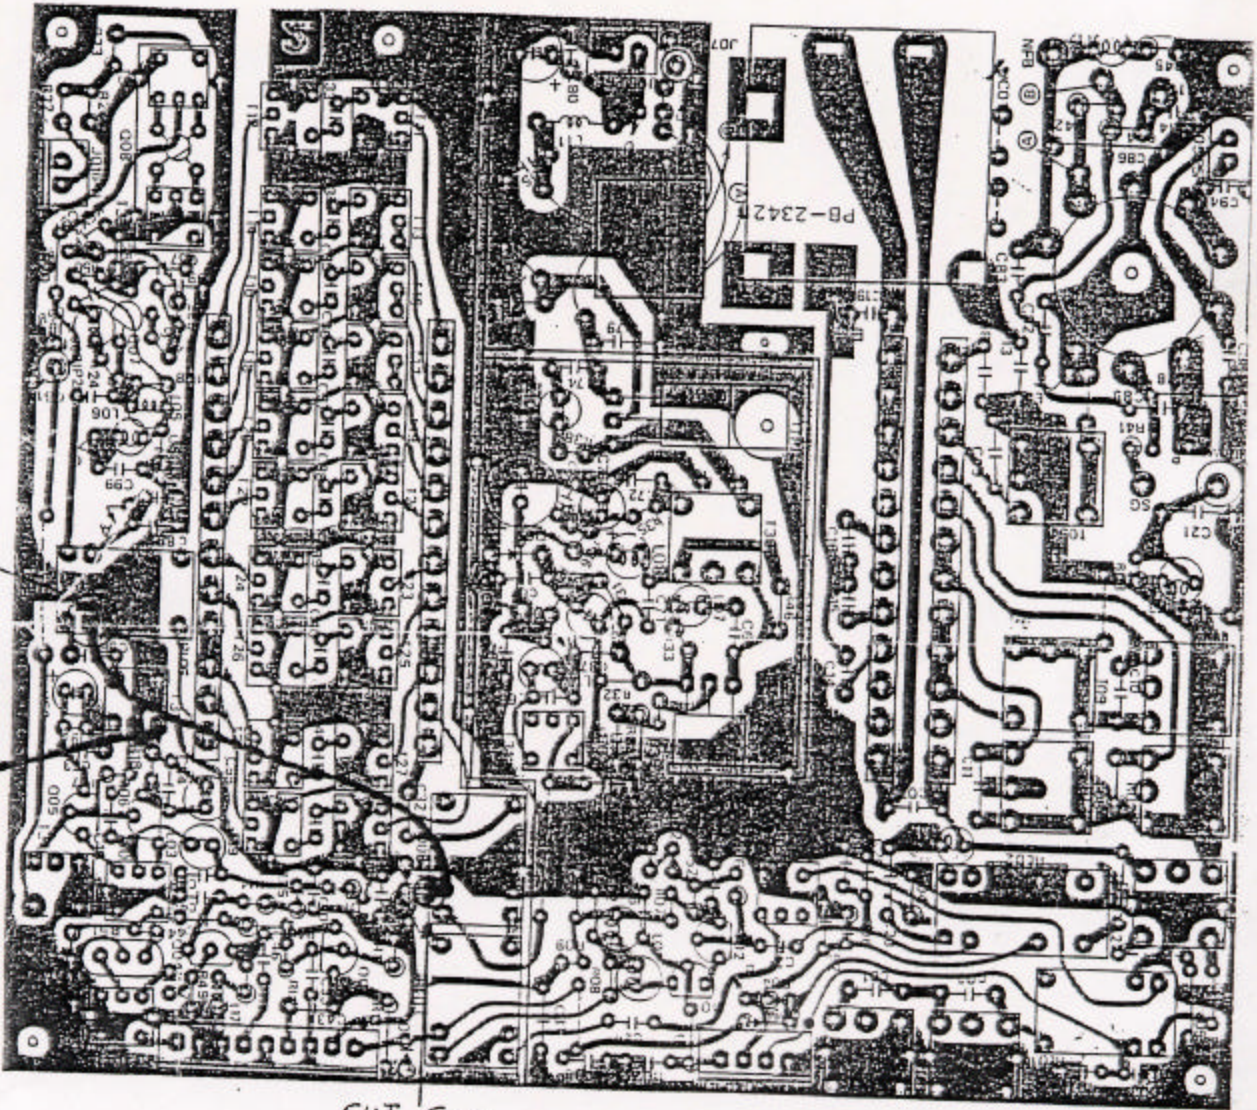
CUT FOIL

ADD WIRE

1. Remove the top and bottom covers.
2. Remove the four (4) screws from the AF unit, also remove the shield cover.
3. Remove the defective relays from the RF unit.
4. Install new relays to the RF unit.
5. Referring to Figure-1, cut the foil and install the jumper wire.
6. Replace the shield cover, AF unit top cover and bottom cover. The modification is now completed.
7. See below for the required parts.
